## "Full" Reserve Study

**Jupiter Lakes Villas Condominium Association,  
Inc.**

**Jupiter, FL**

**Report #: 39297-0**

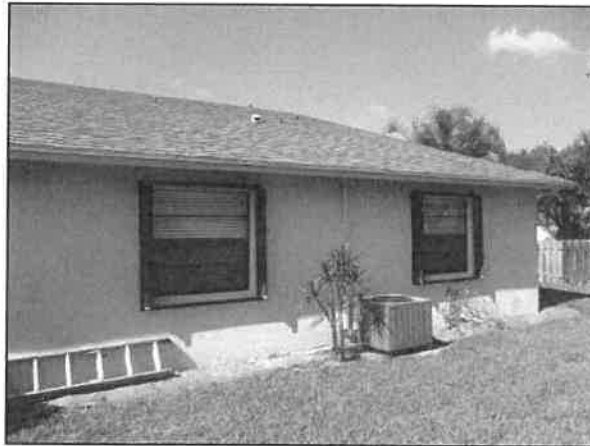
Comments: Approximately 13,400 LF of sealants noted at windows and door frames. Good condition: Painted exterior surfaces determined to be in good condition typically exhibit consistent, attractive color and texture with no unusual or significant signs of wear or deterioration. Appearance is good and upholding the aesthetic standards of the development.

There are two important reasons for painting and waterproofing a building: to protect the structure from damage caused by exposure to the elements, and to restore or maintain good aesthetic standards for curb appeal. As routine maintenance, we recommend that regular inspections, spot repairs and touch-up painting be included in the operating budget. Typical paint cycles can vary greatly depending upon many factors including; type of material painted, surface preparations, quality of material, application methods, weather conditions during application, moisture beneath paint, and exposure to weather conditions. Proper sealant/caulking at window and door perimeters and other "gaps" in the building structure are critical to preventing water intrusion and resulting damage. The general rule of thumb is that sealant/caulking should be in place wherever two dissimilar building material surfaces meet, such as window frame to concrete structure junctions. For best results, the client may want to consult with a paint company representative, building envelope specialist and/or structural engineer to specify the types of materials to be used and define complete scope of work before bidding. In our experience, cost estimates for painting and waterproofing can vary widely, even when based on the same prescribed scope of work. Estimates shown here should be updated and revised as needed based on actual bids obtained or project cost history during future Reserve Study updates.

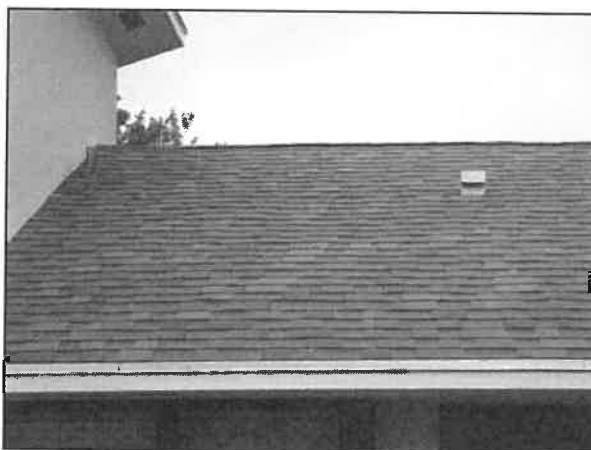
### Comp #: 2381 Roofing (Asphalt Shingle) - Replace

History: Per information provided, all roofs replaced after hurricane Wilma (~2005)

Comments: Fair condition: Asphalt shingle roofs determined to be in fair condition typically exhibit normal signs of wear and deterioration, including some loss of granule cover, and light to moderate curling/lifting, especially in most exposed areas. Overall believed to be aging normally.

Dimensional shingles typically have longer useful lives and are generally considered to be more valuable from an aesthetic standpoint. We recommend budgeting to replace with dimensional shingles upon failure. Also known as architectural shingles, these types of roofs are typically more durable and wind-resistant than 3-tab shingles. Unless otherwise noted, costs shown here assume that only a minimal amount of substrate/decking repairs or replacement will be required. For very old roofs or those with significant leak problems, additional repair costs may be incurred. As routine maintenance, many manufacturers recommend inspections at least twice annually and after large storm events. Promptly replace any damaged/missing sections or conduct any other repair needed to ensure waterproof integrity of roof. Keep roof surface, gutters and downspouts clear and free of moss or debris. Moss growth can decrease the life of the roofing shingles and should be removed promptly. We recommend having roof inspected in greater detail (including conditions of sub-surface materials) by an independent roofing consultant prior to replacement. There is a wealth of information available through organizations such as the Roof Consultant Institute <http://www.rci-online.org/> and the National Roofing Contractors Association (NRCA) <http://www.nrca.net/>. If the roof has a warranty, be sure to review terms and conduct proper inspections/repairs as needed to keep warranty in force.

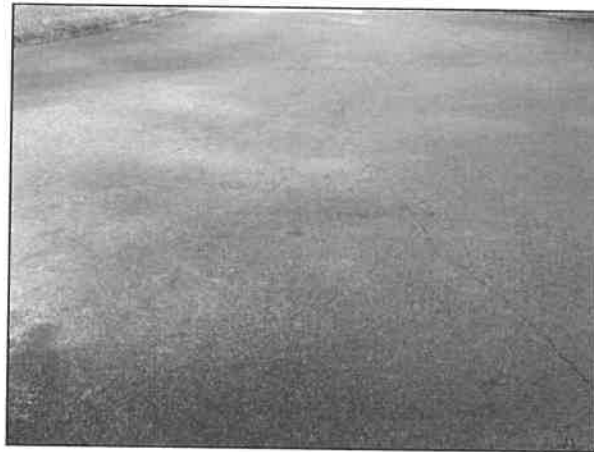
**Comp #: 2123 Asphalt - Seal/Repair****Quantity: Approx 23,400 GSY**

Comments: Fair condition: Asphalt seal-coat determined to be in fair condition typically exhibits a mostly uniform but lighter, faded coloring. Traffic markings still make contrast with pavement, but are showing some fading and wear.

Lower estimate to seal/repair

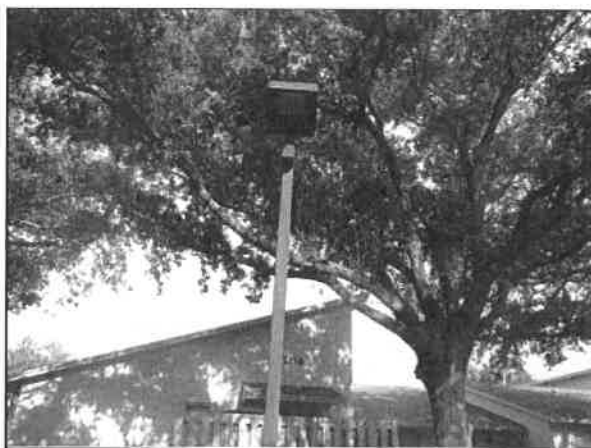
Lights were inspected during daylight hours but are assumed to be functional. Bulbs are expected to be replaced as needed as an Operating expense. Replacement should be considered at the approximate interval shown below to ensure good function and maintain good appearance in the common areas. Replacement costs can vary greatly depending on replacement type; estimates shown here are based on replacement with a comparable size and design as are currently in place, unless otherwise noted.
