**2026 Update to the Reserve Study for**

**Jupiter Lakes Villas Condominium Association, Inc.  
Jupiter, FL**

**December 18, 2025**

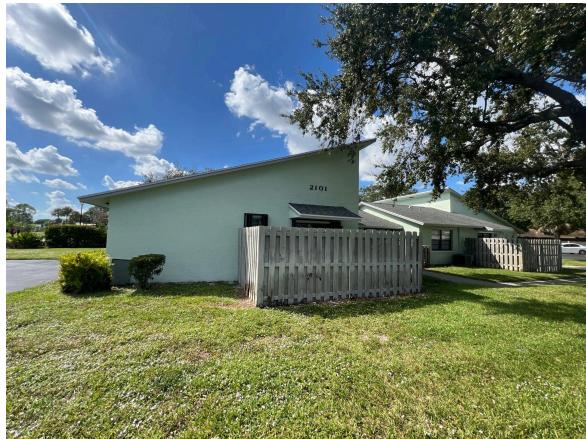
Dwelling building

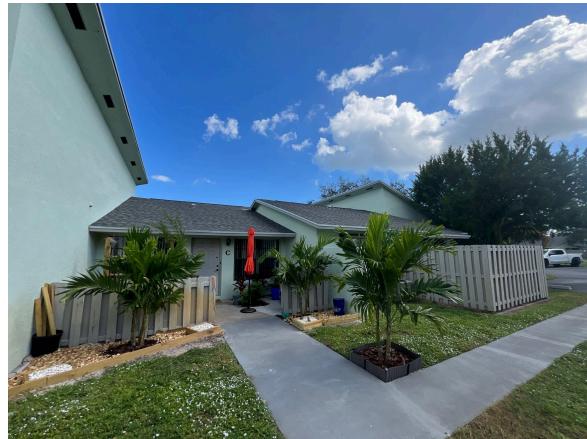
Dwelling building

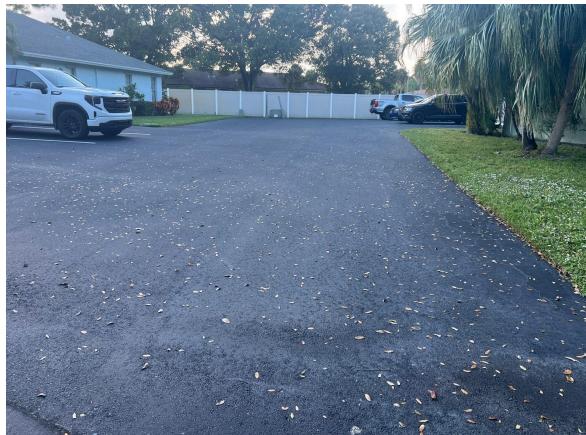
- Per information provided by the client, the parking areas patch and seal was completed in June 2024 for \$37,589.60, and the asphalt streets patch and seal was completed in October 2025 for \$20,548. No invoices were provided to Global Solution Partners. Asphalt surfaces should be resealed on a five-year schedule to provide protection from oxidation due to exposure to the sun and elements, minimize surface cracking, and enhance the aesthetics of the community. Per information provided by the client, contractor recommendations are to mill and overlay the asphalt streets and parking mill and overlay.

Asphalt-paved parking

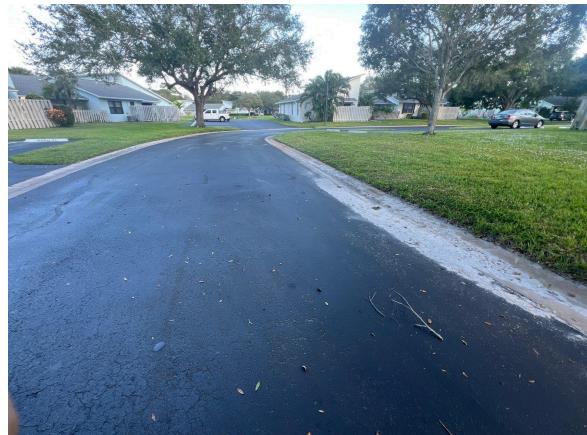
Asphalt-paved street

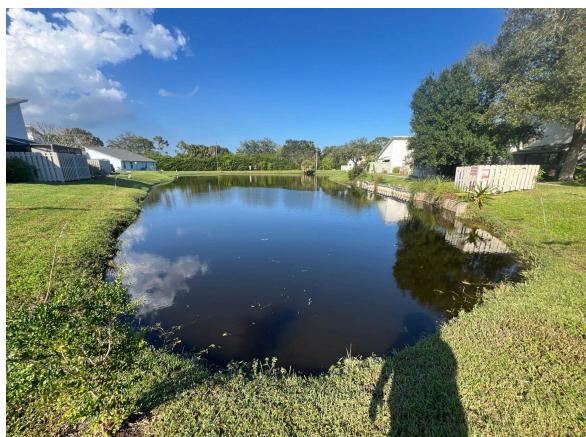
- There is one retention pond located on site. Global Solution Partners recommends implementing a regular maintenance schedule for the pond to help preserve its functionality and extend its useful lifespan. Consistent upkeep minimizes sediment buildup, manages vegetation, and ensures the pond's design features continue to operate effectively. Consult a qualified contractor for maintenance recommendations and schedules. Contractor recommendations may be used in future updates to this Reserve Study.

Pond

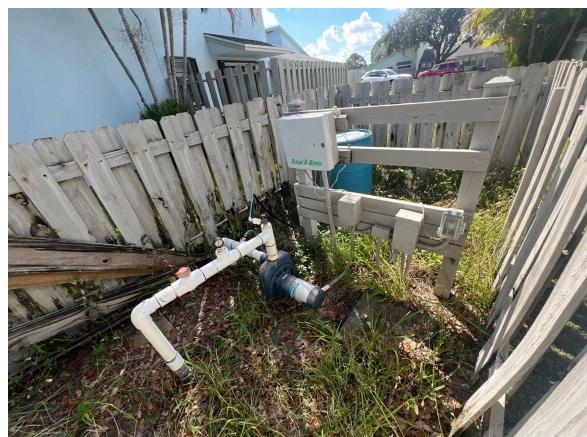
- Per information provided by the client, the irrigation system is not operating properly. Global Solution Partners recommends repairing the irrigation system. Irrigation system repairs have been included in this Reserve Study.

Irrigation system

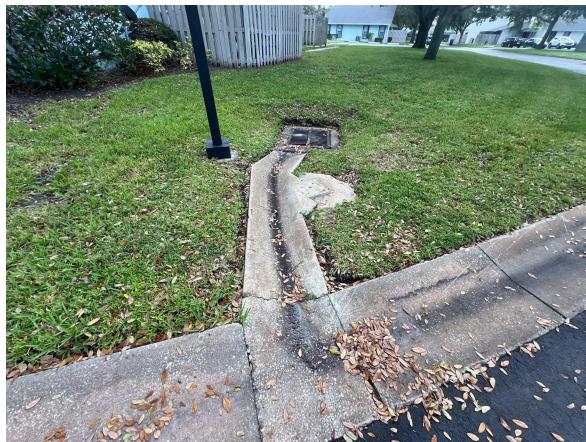
- There is a localized damaged section of culvert near a stormwater drain in a grassy area at building 2130. Global Solution Partners recommends repairing the damaged section of the culvert using operational funds as part of routine site maintenance.

Damaged culvert

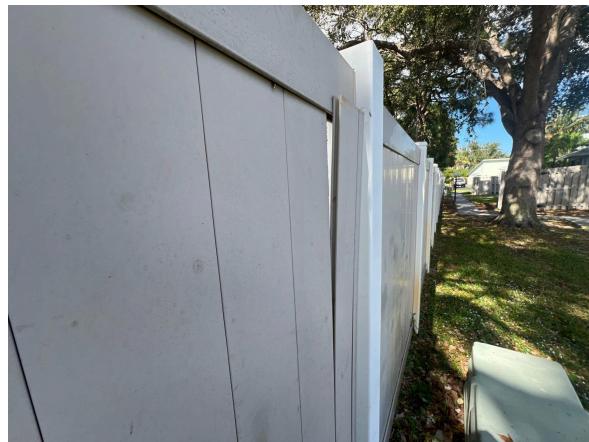
- There are loose and damaged sections of PVC fencing and missing post caps in various locations. Global Solution Partners recommends replacing the PVC fencing. PVC fencing replacement has been included in this Reserve Study.

Damaged PVC fencing

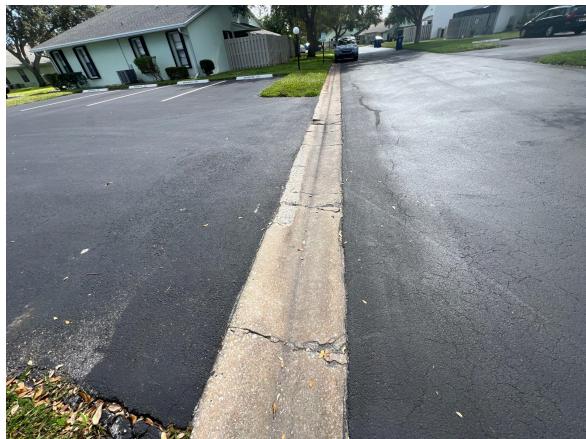
- There is damaged curbing/guttering throughout the community. Global Solution Partners recommends repairing the damaged curbing/guttering. A curbing/guttering repair allowance (10% every 10 years) has been included in this Reserve Study.

Damaged curbing/guttering

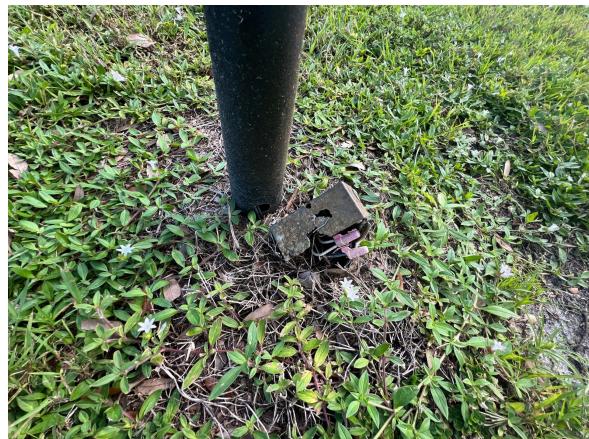
- There is exposed electrical wiring at the post lighting for the mailboxes in front of building 2115. Global Solution Partners recommends repairing the exposed electrical wiring using operational funds as part of routine site maintenance.

Exposed electrical wiring

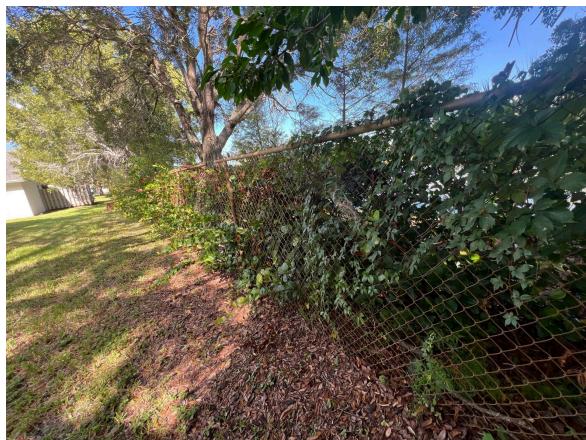
- The chain-link perimeter fencing is damaged and worn. Global Solution Partners recommends replacing the chain-link fencing. Chain-link fencing replacement has been included in this Reserve Study.

Damaged/worn chain-link fencing

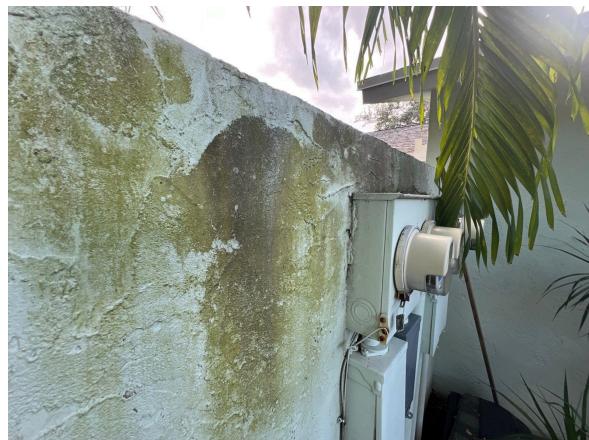
- There is localized staining on the block and stucco walls in various locations for the rear yards. Global Solution Partners recommends painting the stained block and stucco walls using operational funds as part of routine site maintenance. A reserve item for painting of the block and stucco walls has been included in this Reserve Study to coincide with the exterior siding painting.

Staining on rear yard block and stucco walls

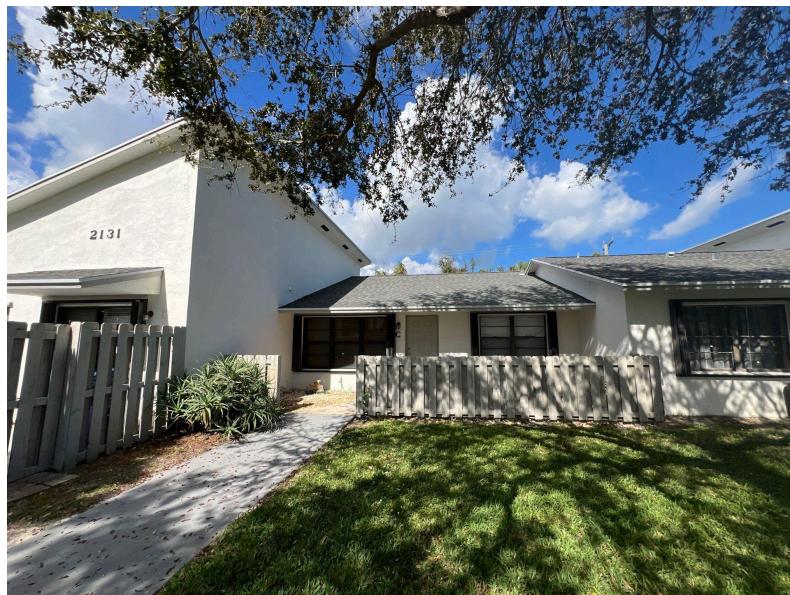
### Dwelling Unit Buildings

Item Name	Present Cost	Remaining Life	Expected Life	First Expense Year	First Expense	Repeating Item?
Dimensional asphalt shingle roofing replacement	\$831,774.54	20 Yrs	25 Yrs	2046	\$1,381,696.74	Y
Exterior siding surfaces painting	\$489,383.61	3 Yrs	8 Yrs	2029	\$528,093.09	Y
Stucco exterior siding surfaces repair allowance (10% every 14 years)	\$236,923.81	3 Yrs	14 Yrs	2029	\$255,664.12	Y

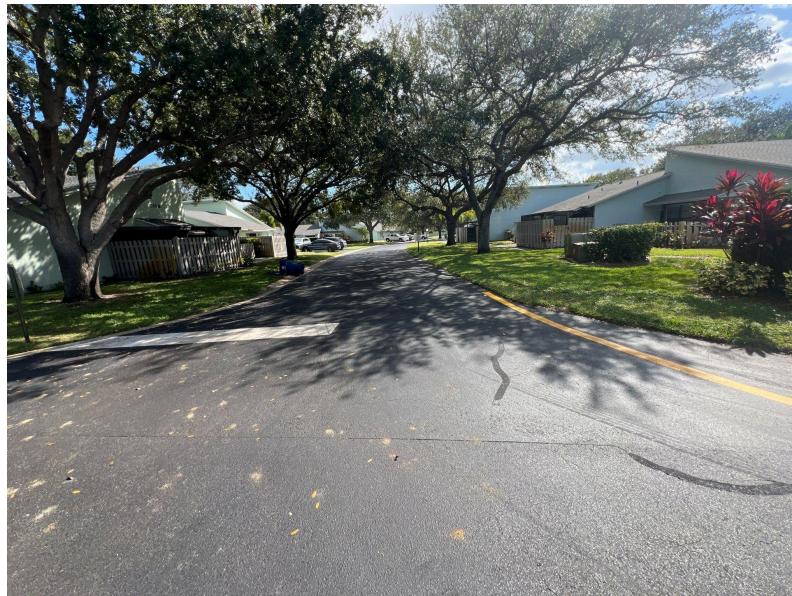
## Paving

Item Name	Present Cost	Remaining Life	Expected Life	First Expense Year	First Expense	Repeating Item?
Asphalt parking areas mill and overlay	\$569,434.92	4 Yrs	25 Yrs	2030	\$630,268.37	Y
Asphalt parking areas patch and seal	\$32,579.61	9 Yrs	5 Yrs	2035	\$40,938.23	Y
Asphalt streets mill and overlay	\$230,155.91	4 Yrs	25 Yrs	2030	\$254,743.76	Y
Asphalt streets patch and seal	\$13,401.48	9 Yrs	5 Yrs	2035	\$16,839.77	Y
Concrete curbing/guttering repair allowance (10% every 10 years)	\$15,350.56	0 Yrs	40 Yrs	2026	\$15,350.56	Y
Concrete parking stops replacement	\$29,175.74	8 Yrs	25 Yrs	2034	\$35,742.49	Y
Concrete walkways repair allowance (10% every 10 years)	\$22,514.30	10 Yrs	10 Yrs	2036	\$29,017.64	Y
